THE STRAWBERRY CREEK AND PYRAMID GUARD STATION LANDSLIDES

A Thesis

Steven Francis Connelly

June 1988

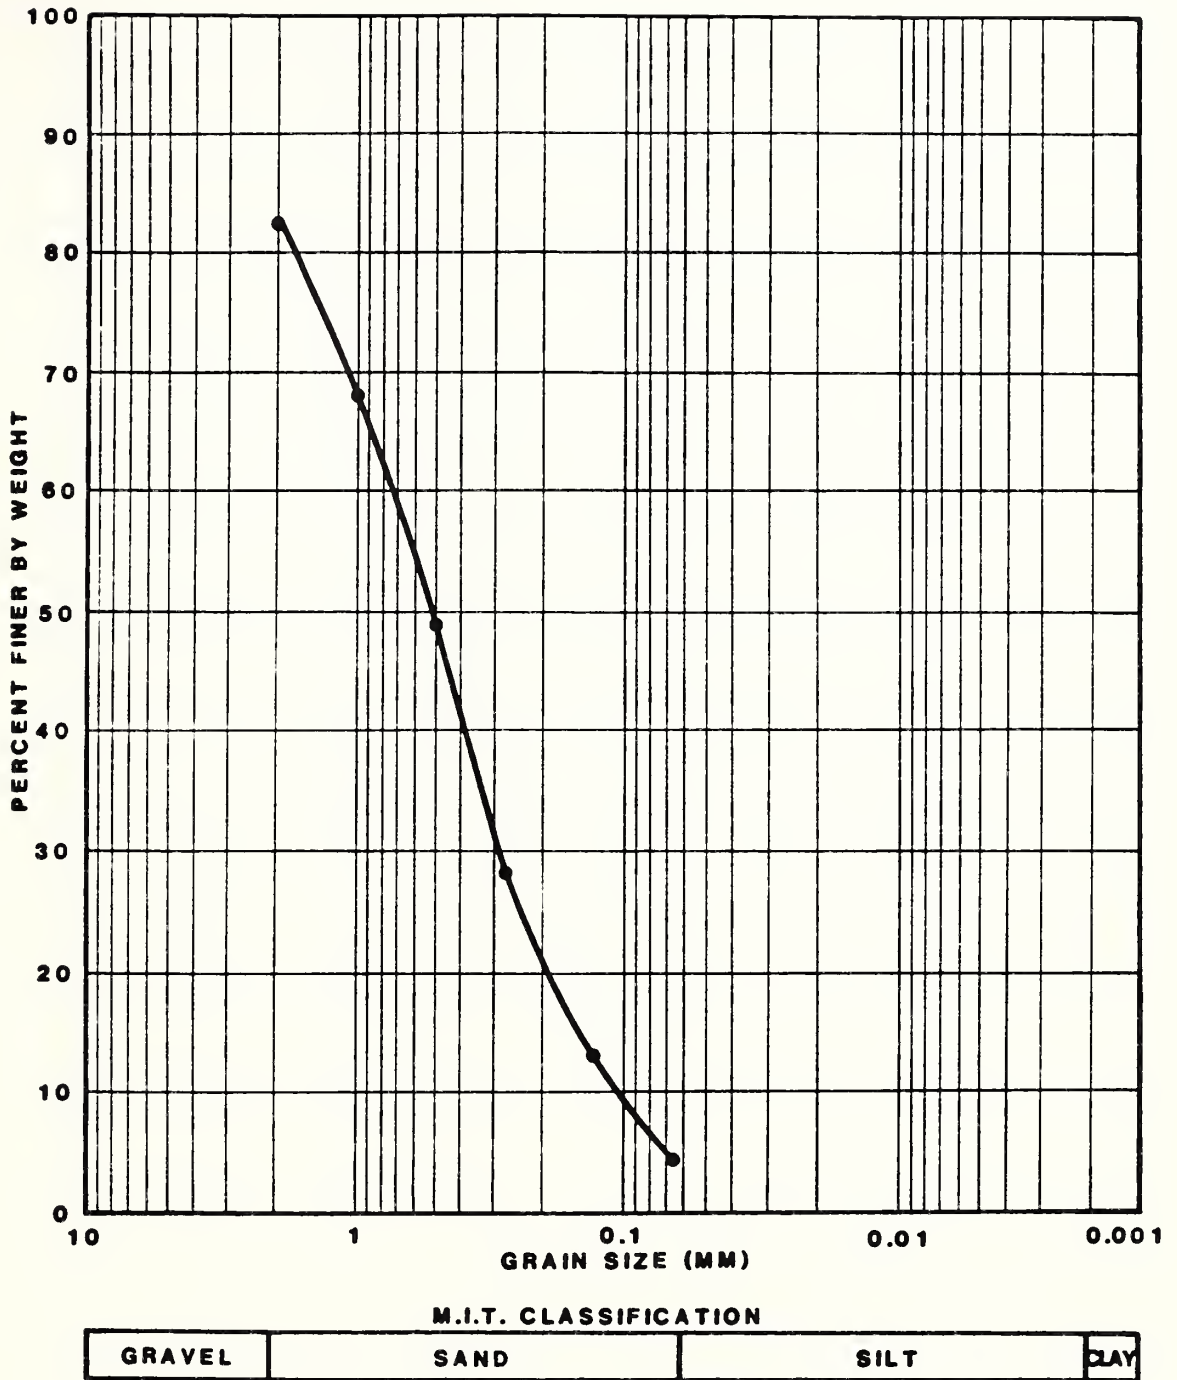
Graph 6. Pyramid Guard Station landslide sample 7: Lithic Xerumbrepts-Rock outcrop complex soil (points indicate sieve size openings).

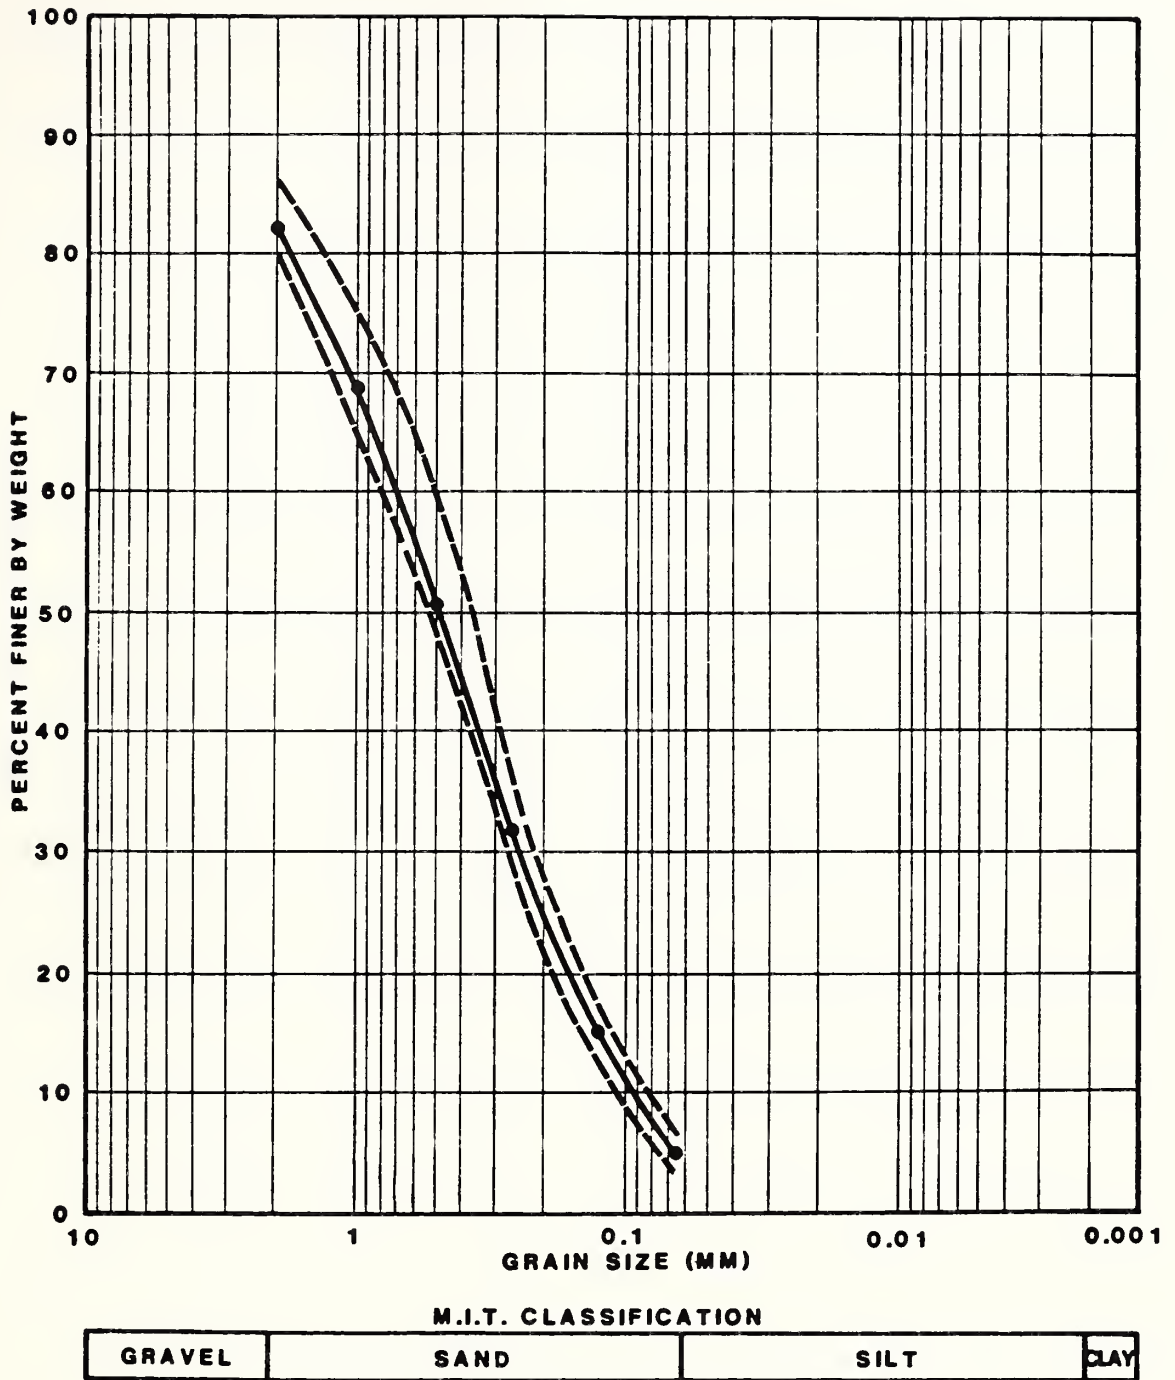
Graph 7. Pyramid Guard Station landslide: brown debris-flow deposit (points indicate sieve size openings, solid line indicates average curve, dashed lines indicate range).

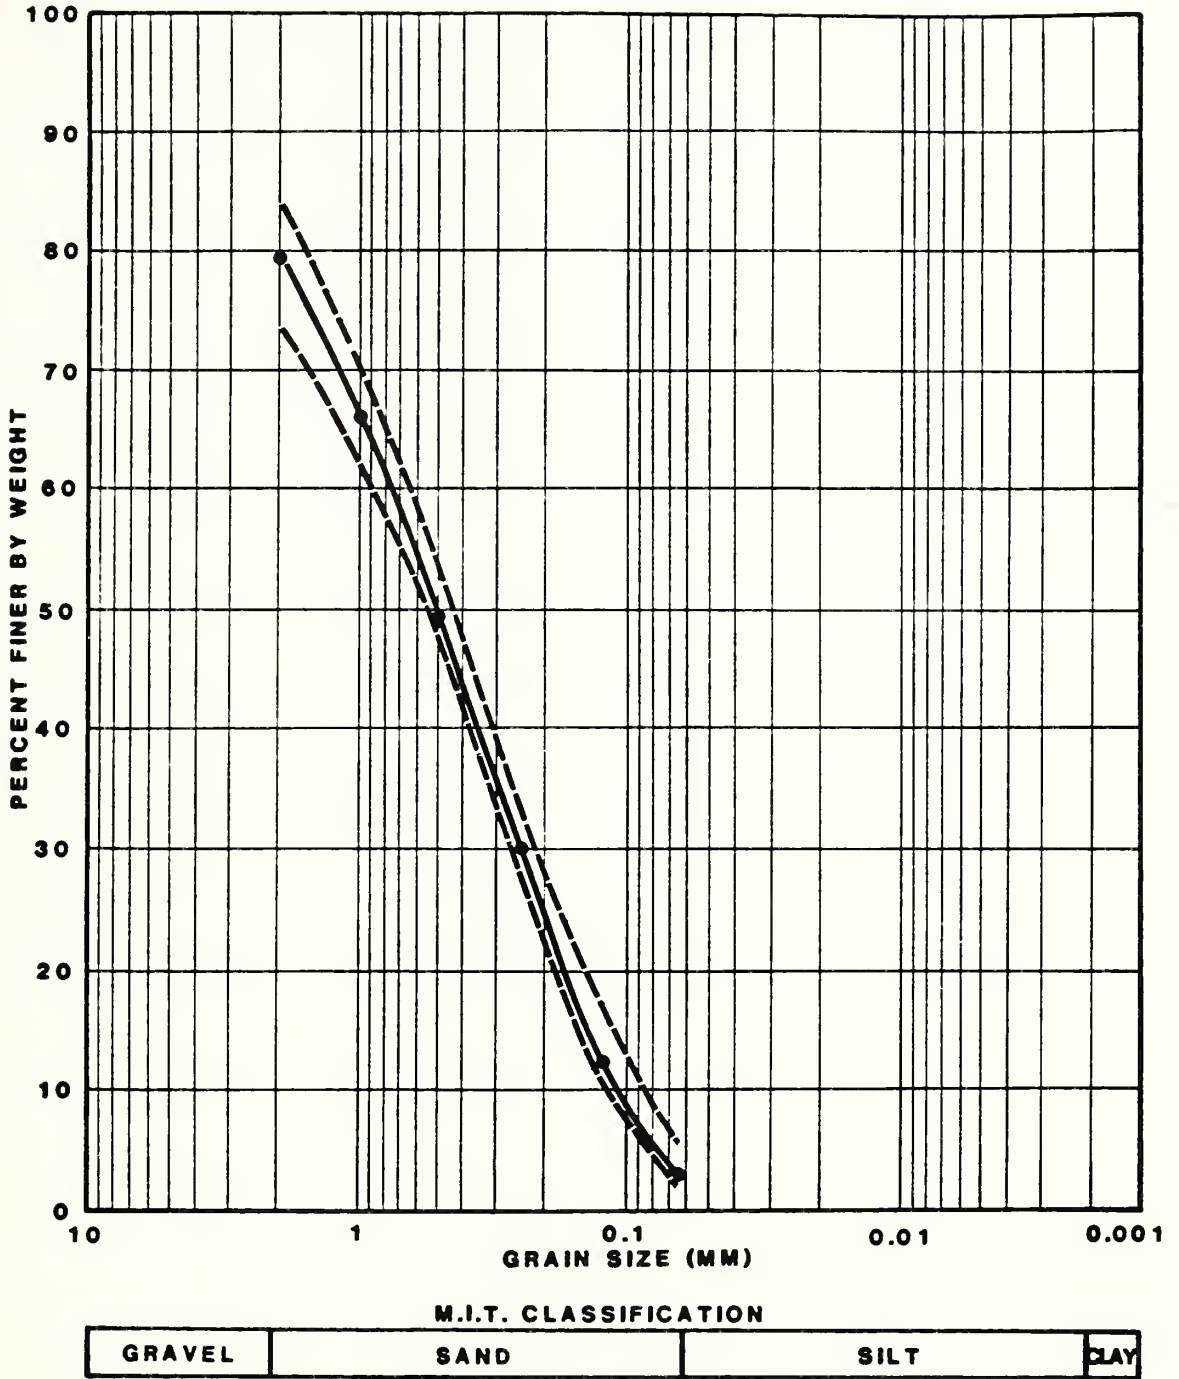
Graph 8. Pyramid Guard Station landslide: gray debris-flow deposit (points indicate sieve size openings, solid line indicates average curve, dashed lines indicate range).

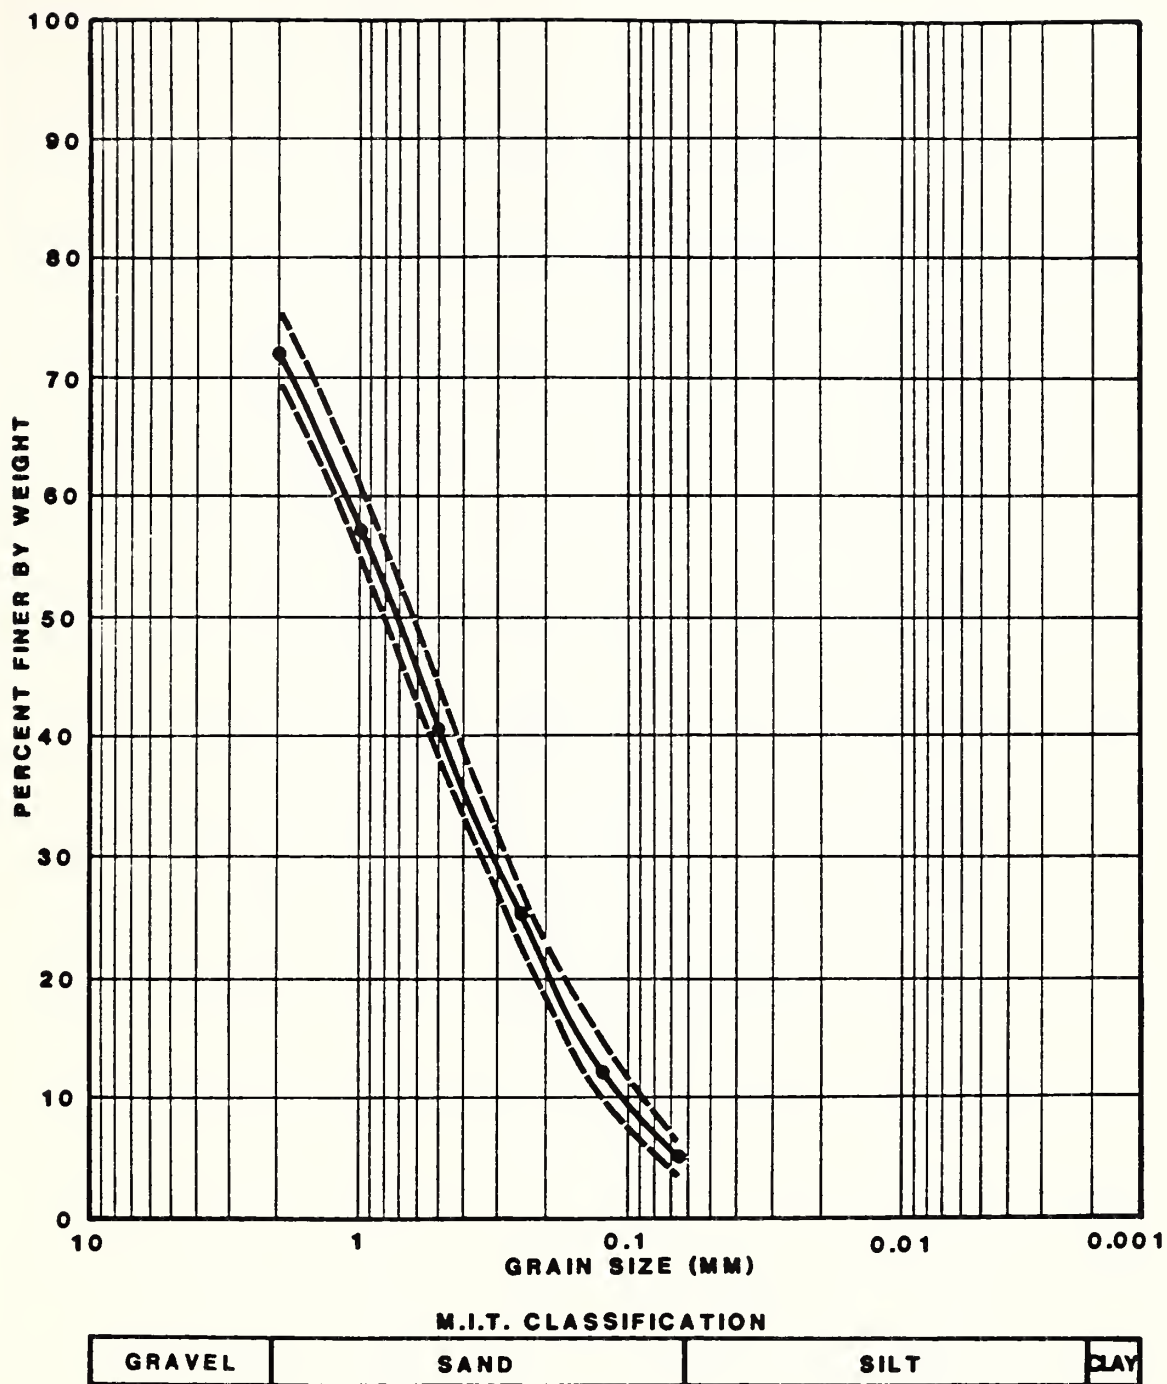
Graph 9. Pyramid Guard Station landslide: undifferentiated debris-flow deposit (points indicate sieve size openings, solid line indicates average curve, dashed lines indicate range).

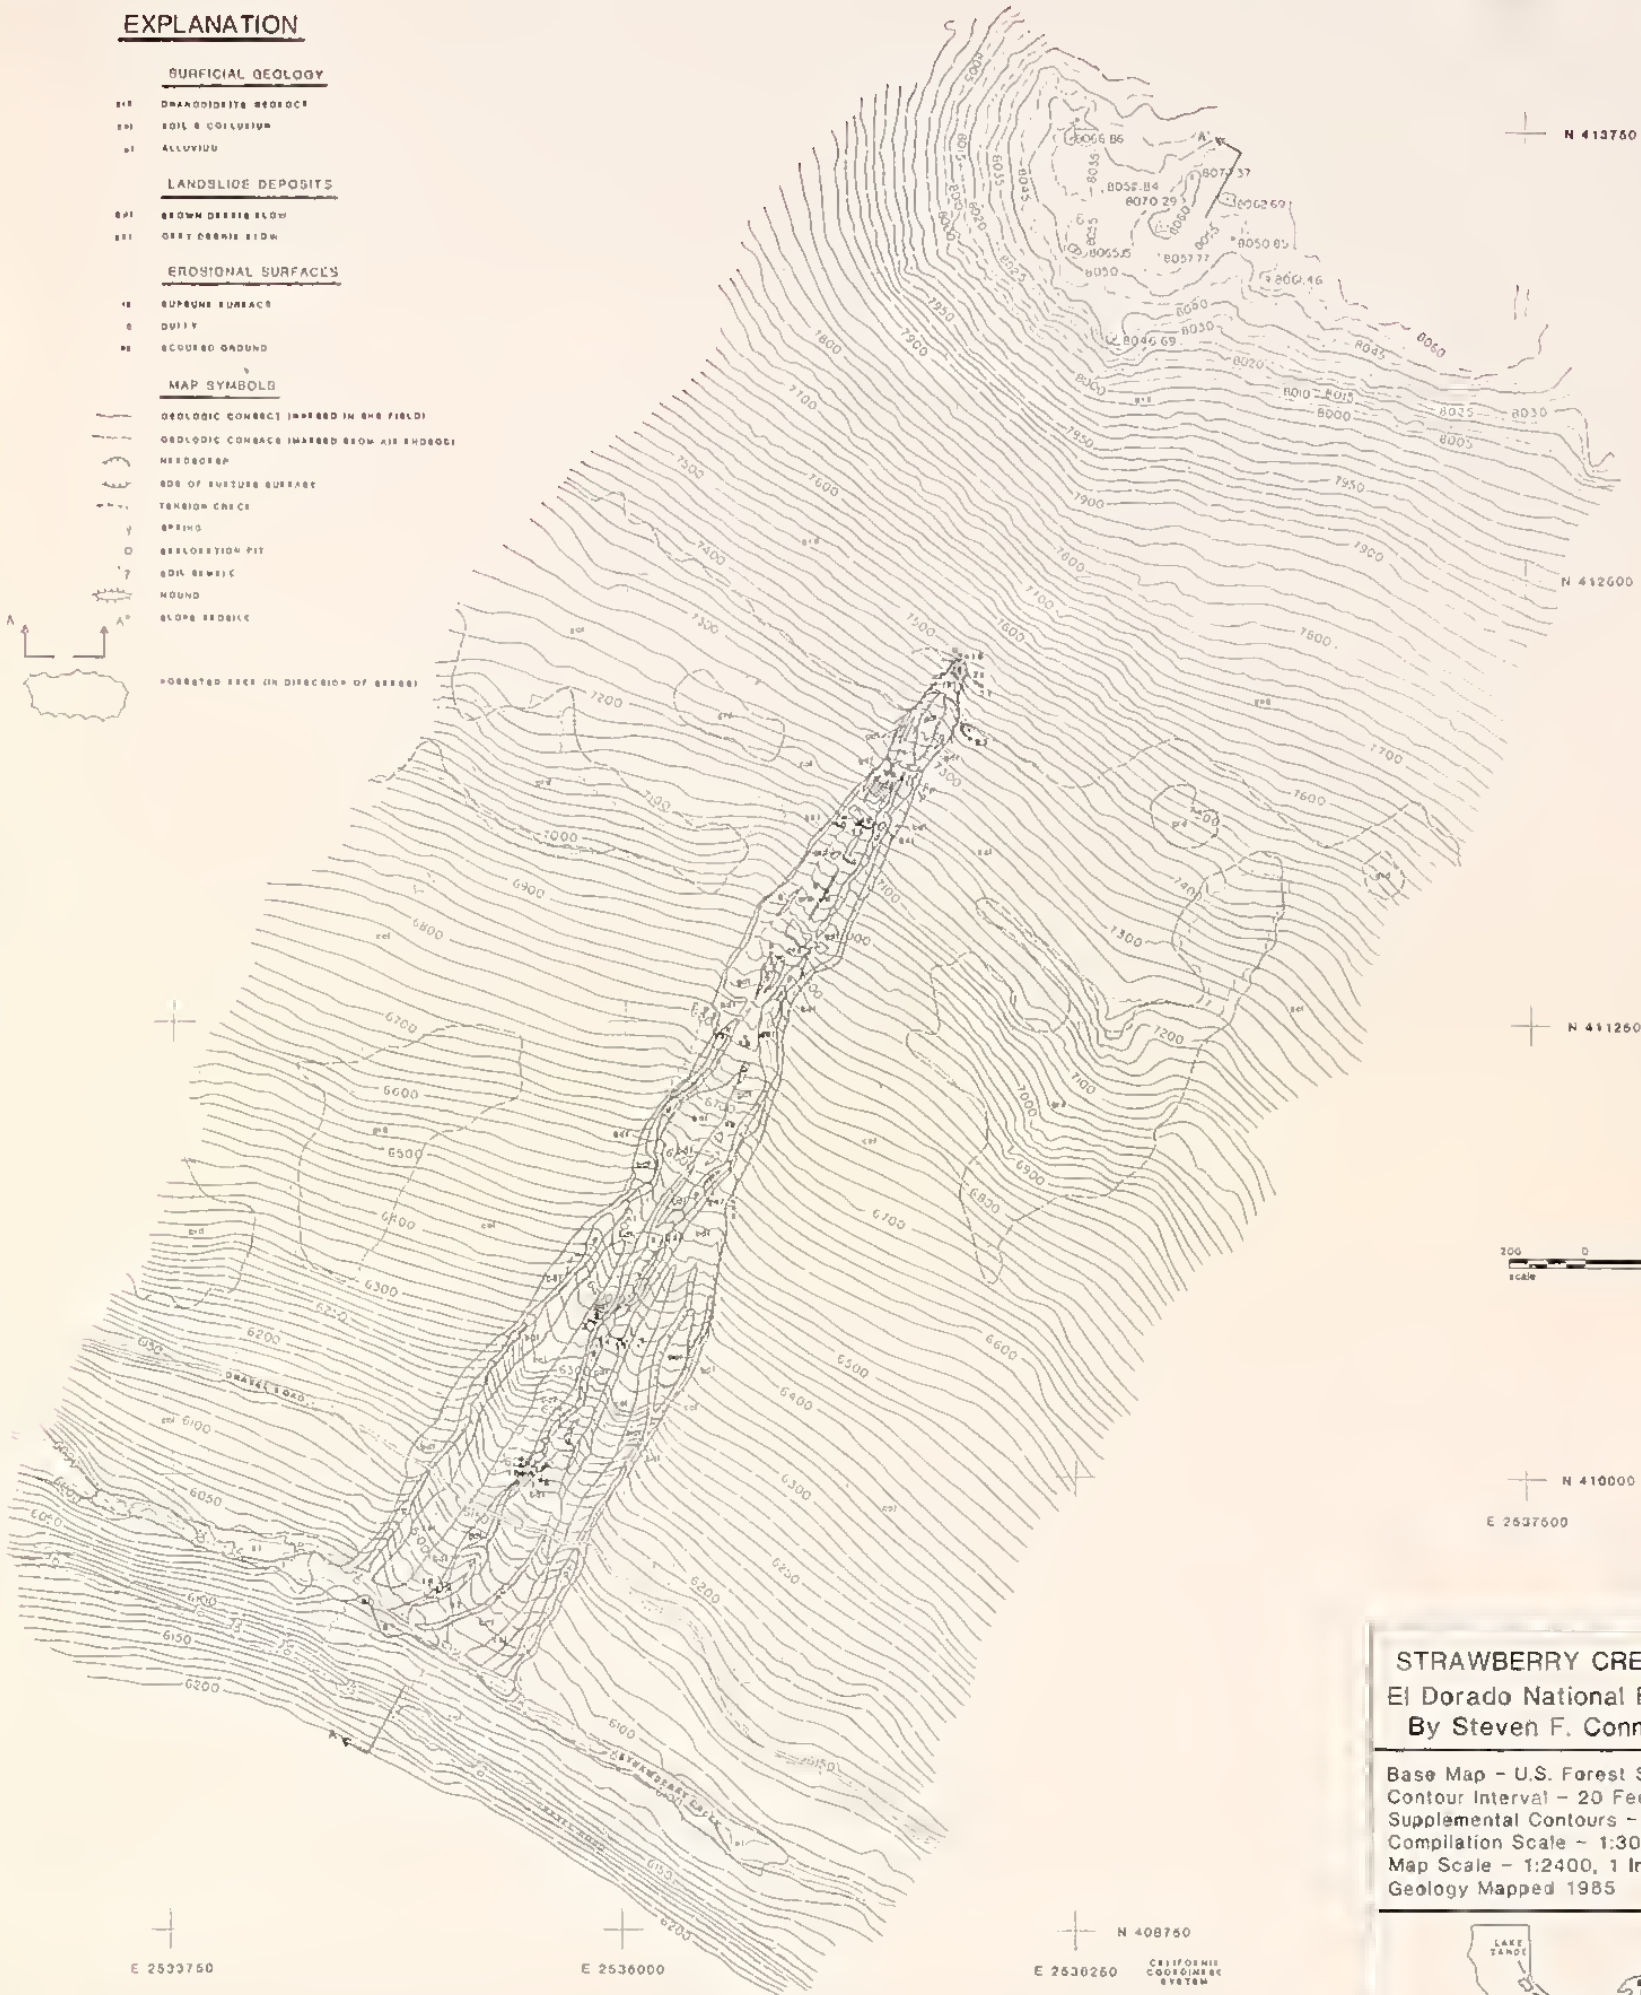
- GEOLOGIC CONTACT (IMAGED IN THE FIELD)
- GEOLOGIC CONTACT (IMAGED FROM AIR PHOTOGRAPH)
- BED OF FUTURE SURFACE
- TENSION CRACK
- SPRING
- EXPLORATION PIT
- SOIL BERM(S)
- MOUND
- SLOPE INDICATOR

— OBSERVED FEE (IN DIRECTION OF STREAM)

Scale 0 200 400 Feet

Several springs, shown on Plate 1, are located along the western margin of the landslide at an elevation of approximately 6,810 feet. A number of springs occur within and at the margins of the landslide near the 7,280 foot contour level. Water was actively seeping from the springs within the landslide at that elevation during field investigations of the summer of 1985. There are no major drainages on the slope near the landslide. However, a minor ephemeral creek located near the northwest margin of the landslide is evident in aerial photographs taken prior to the landslide failure.

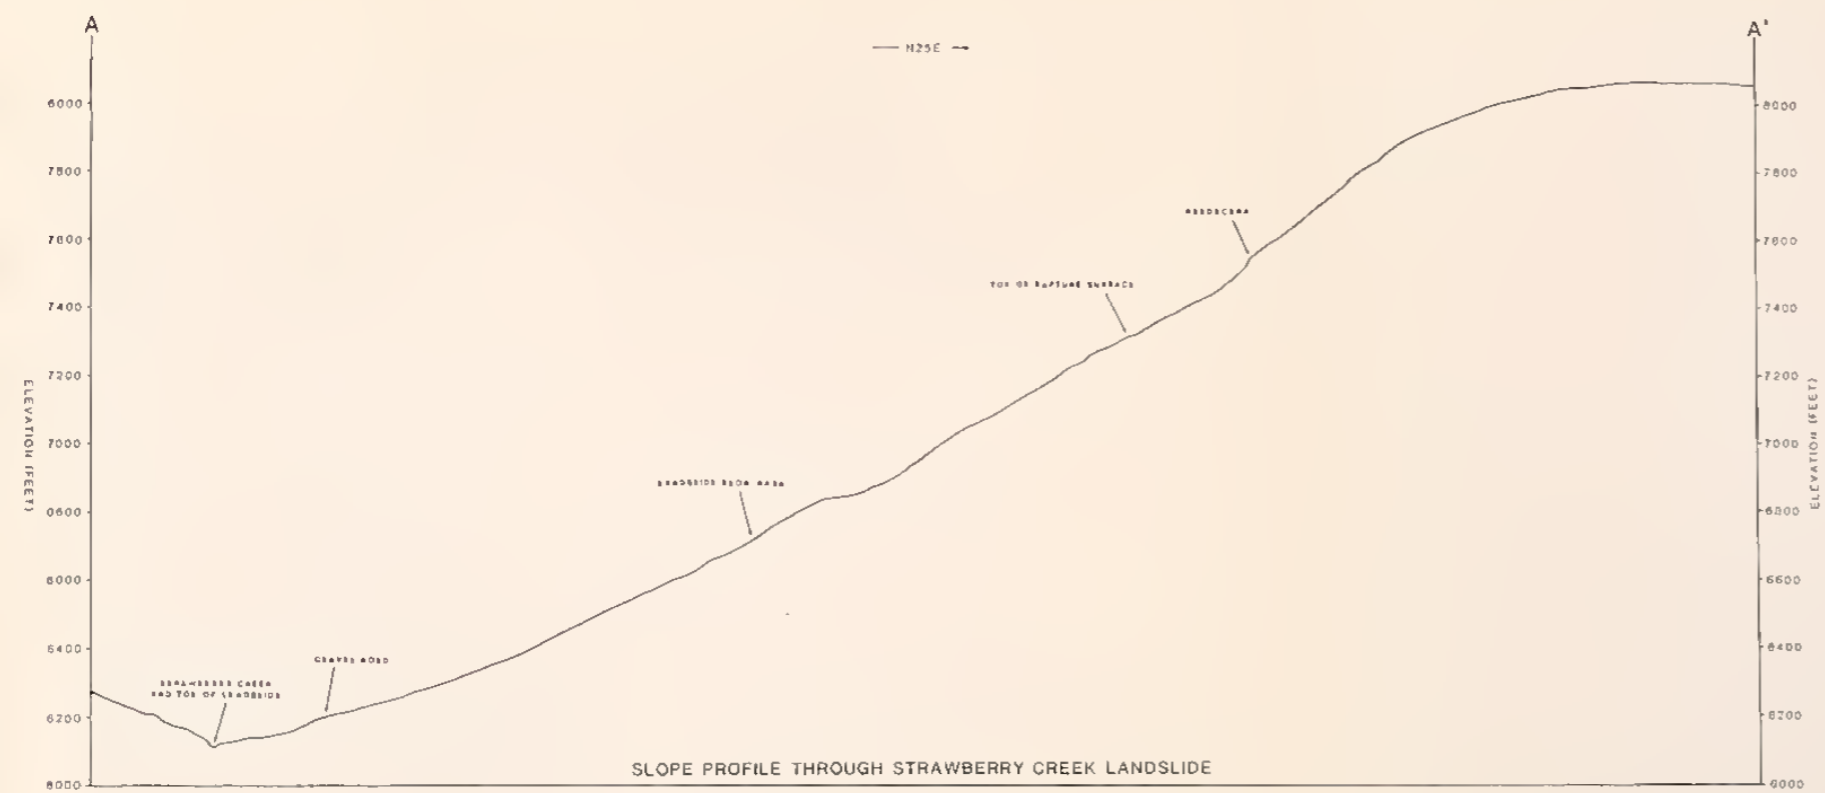
**SLOPE PROFILES A-A' AND B-B'**  
 STRAWBERRY CREEK AND PYRAMID GUARD STATION LANDSLIDES  
 By Steven F. Connelly, June 1988  
 Base - U.S. Forest Service Geomatics  
 Scale - 1 Inch = 200 Feet
